A story of elevated leakage, whales and the forensics journey...

AKA... Brittle Stress Cracking of HDPE Geomembrane caused by Localized Over-Heating of Fusion Wedge Welds

GEOANZ #1

ADVANCES IN GEOSYNTHETICS
7-9 JUNE 2022 | BRISBANE CONVENTION & EXHIBITION CENTRE

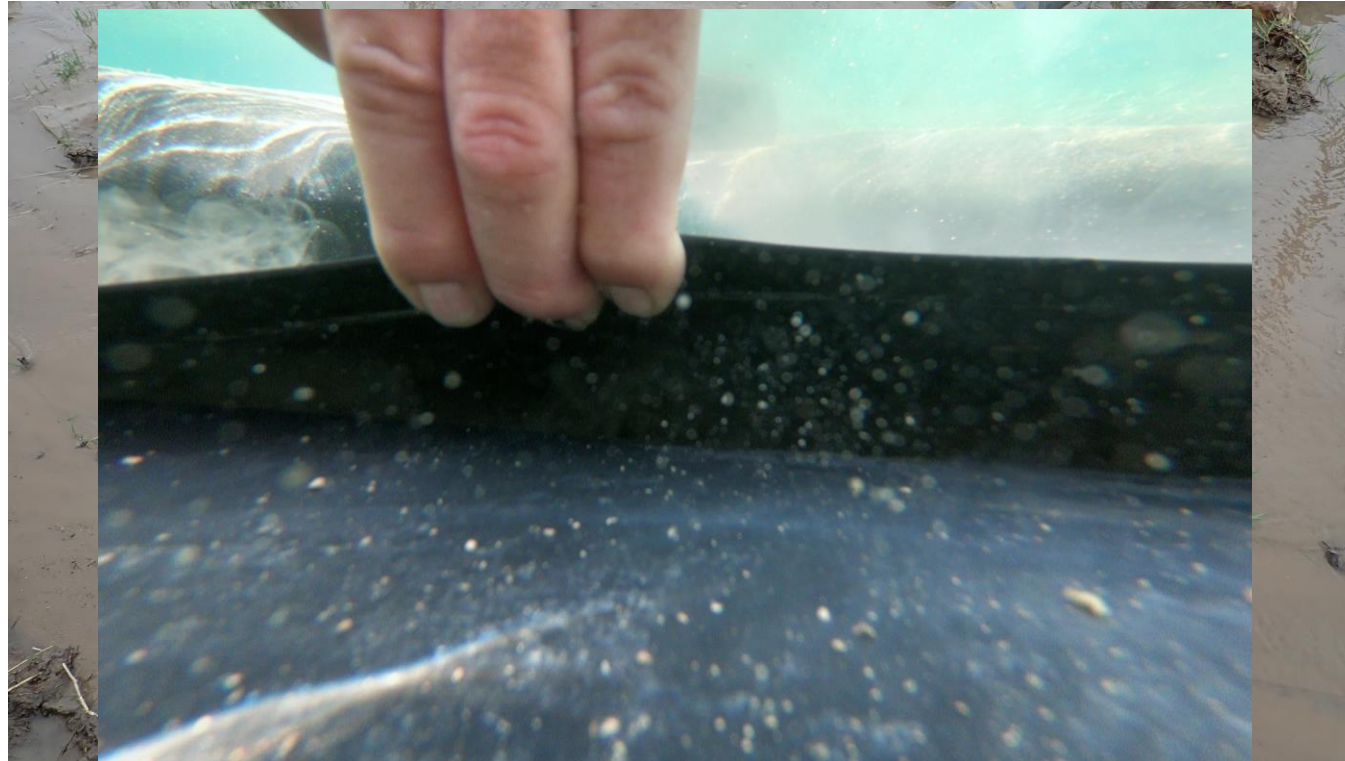
- It can be said that a geomembrane liner system is only as strong as its weakest weld
- Peak leakage rate in excess of 10,000 lpd which was >>>> the Action Leakage Rate (ALR)
- Whales developed during operations which contained gas (in this case air)
- A number of geomembrane cracks (or splits) were identified in the vicinity of the whales
- Failure analysis of one of the geomembrane splits was undertaken

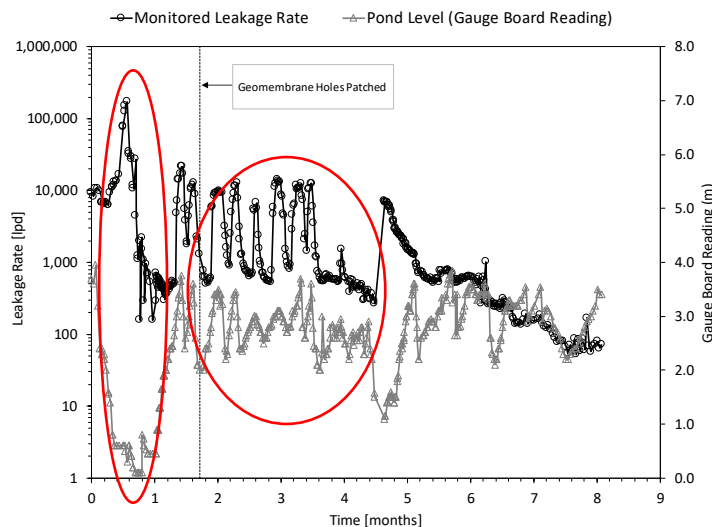
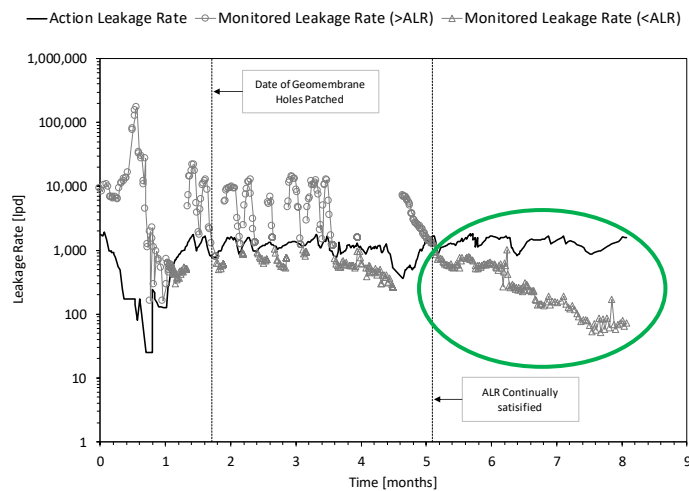
- The good news is that leakage was being monitored against established ALRs
 - The term 'action leakage rate' is used to quantify the limit between acceptable and unacceptable leakage rates
- The not so good news is that leakage was >>>> ALRs
- This exceedance required the Trigger Action Response Plan (TARP) to be followed
- The importance of **composite action** and loss of **intimate contact** – peak leakage rate > 100,000 lpd
- When filling commences and you have a clear hydraulic connection and a very small time-lag it's usually a clear indicator of large 'holes' in the geomembrane.

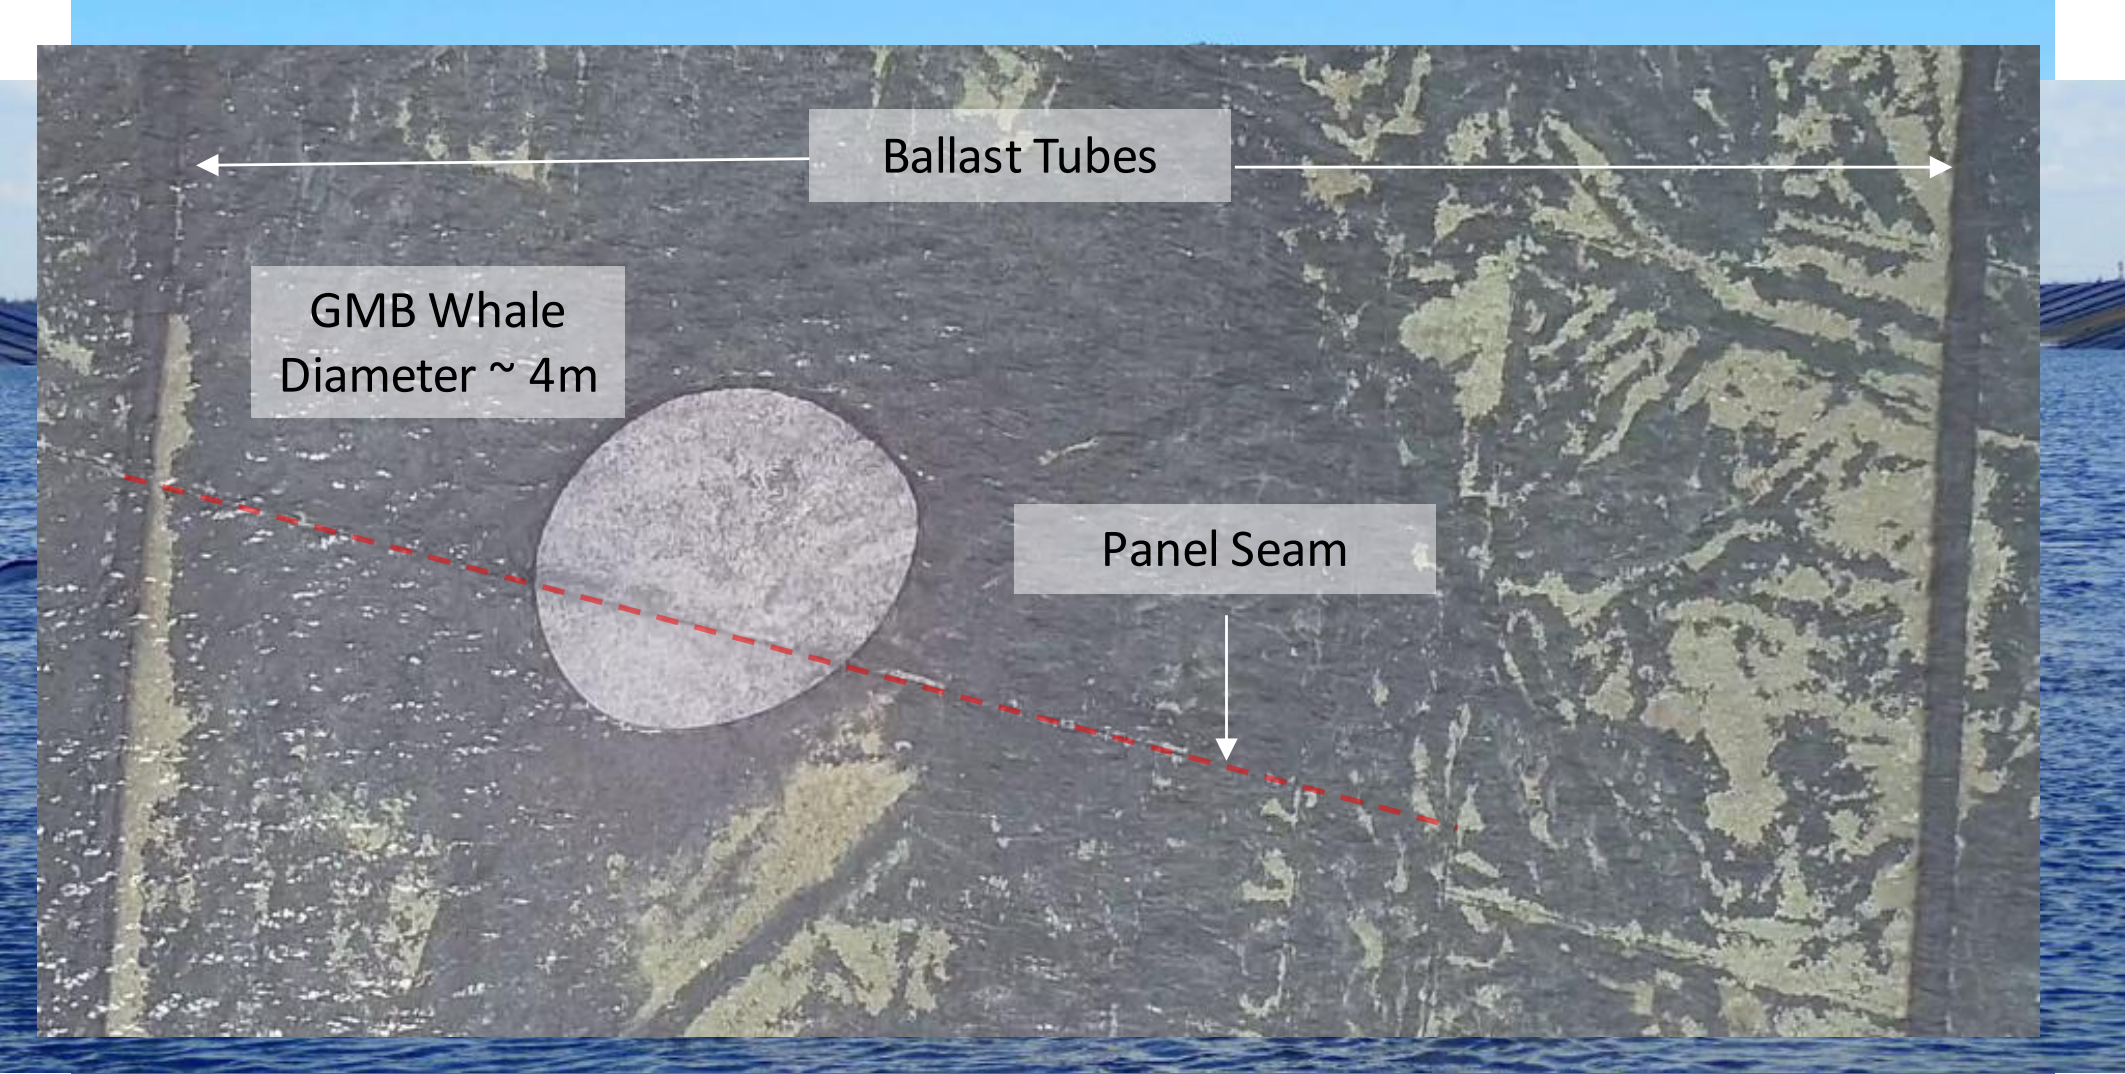
Walking the whales...

- Geomembrane whales developed on the pond floor while the pond was in service
 - Whales are bubbles of air (or other types of gas in some cases) that develop under the geomembrane and appear as 'whale backs' above the surface of the water
 - They exert out-of-plane stresses in the geomembrane
 - Once initial geomembrane deformation occurs, the air tends to concentrate in localised areas beneath the geomembrane, causing the whale to grow over time
 - It is possible for whales to cause bursting failure¹ of the geomembrane.
- There are many possible causes of whales, including:
 - 1) Trapped air (typically in wrinkles) during construction which has not been expelled
 - 2) Air is potentially entering at geomembrane hole locations (via syphoning)
- The whales were 'walked out' towards the batters where air vents were installed near the crest

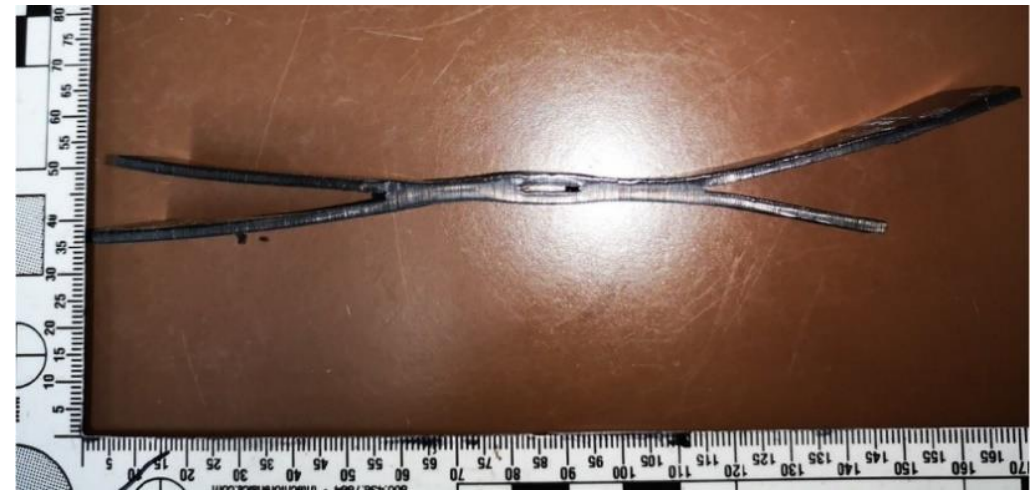
Weld profile dimensions...~10% thickness reduction

Dimension (mm)	Sample 1	Sample 2	Sample 3
Thickness of liners	3.93	3.91	3.93
Thickness of seam	3.54	3.49	3.55
Seam reduction thickness	0.39	0.42	0.38
Air channel width	8.72	8.37	8.96
Weld width	11.8	11.8	12.2
Width of squeeze out bead	4.81	4.88	4.98

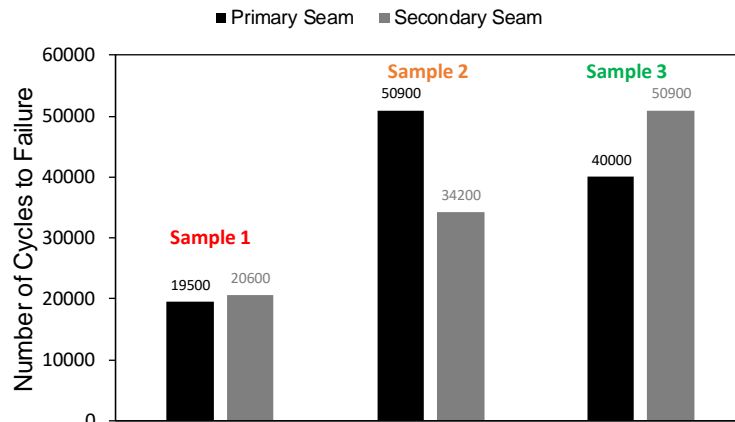
Sample 1 – brittle cracking (i.e., stress cracking) and fails directly on the edge of the weld

Sample 2 – brittle cracking (i.e., stress cracking) and fails directly on the edge of the weld and approx. 20 mm from the edge of the weld track

Sample 3 – ductile failure approx. 30 mm from the edge of the weld track
