# Use of HDPE Vertical Barrier Wall for Remediation of Hazardous Waste Dumpsite

Hermann NG & J.H. SU  
SOLMAX Geosynthetics

**ADVANCES IN GEOSYNTHETICS**  
7-9 JUNE 2022 | BRISBANE CONVENTION & EXHIBITION CENTRE

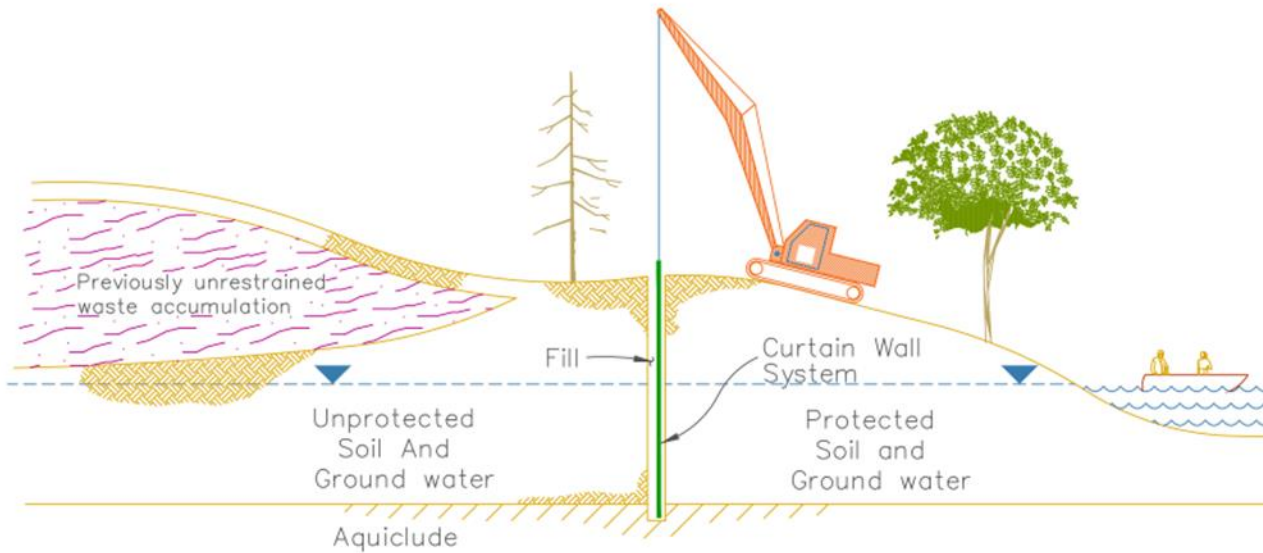
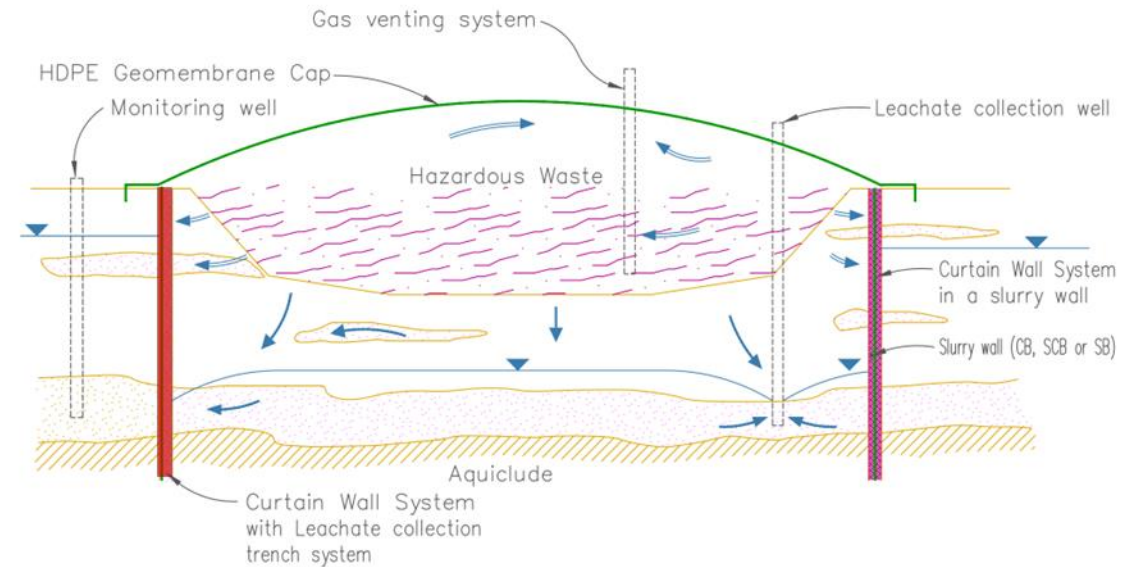
# Vertical Barrier Wall Systems

VB system has been widely used to arrest further migration of contaminants, protect underground water, contain the contaminated area, allow contractors to return to the site at a later time for remediation.

It can also be welded to a GMB cap to prevent the infiltration of rainwater as shown on the right diagram, reduce leachate loading and to contain any volatile components or gas emissions.

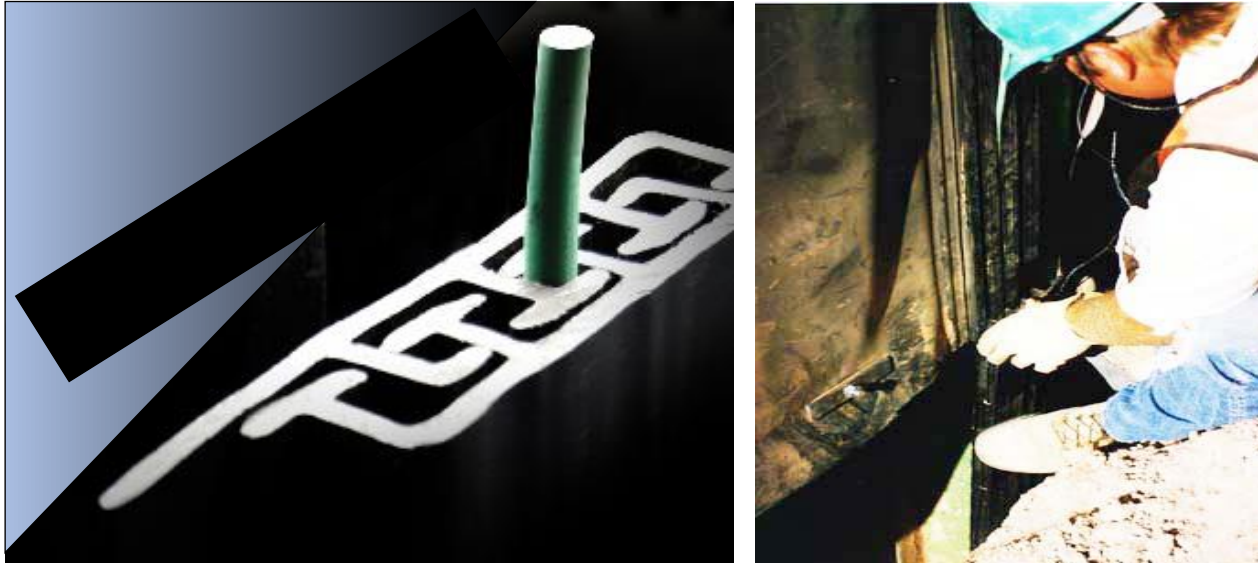
# HDPE Vertical Barrier : CurtainWall

- Reversible HDPE profile
- Interlock profile designed with multiple sealant chambers to accommodate a variety of sealing
- Hydrophilic sealant (HyperTite) is inserted to ensure water tightness of interlock profile. Integrity of joint is important
- Designed for trenched applications, depth is only limited by excavation
- Available in large widths

Top view

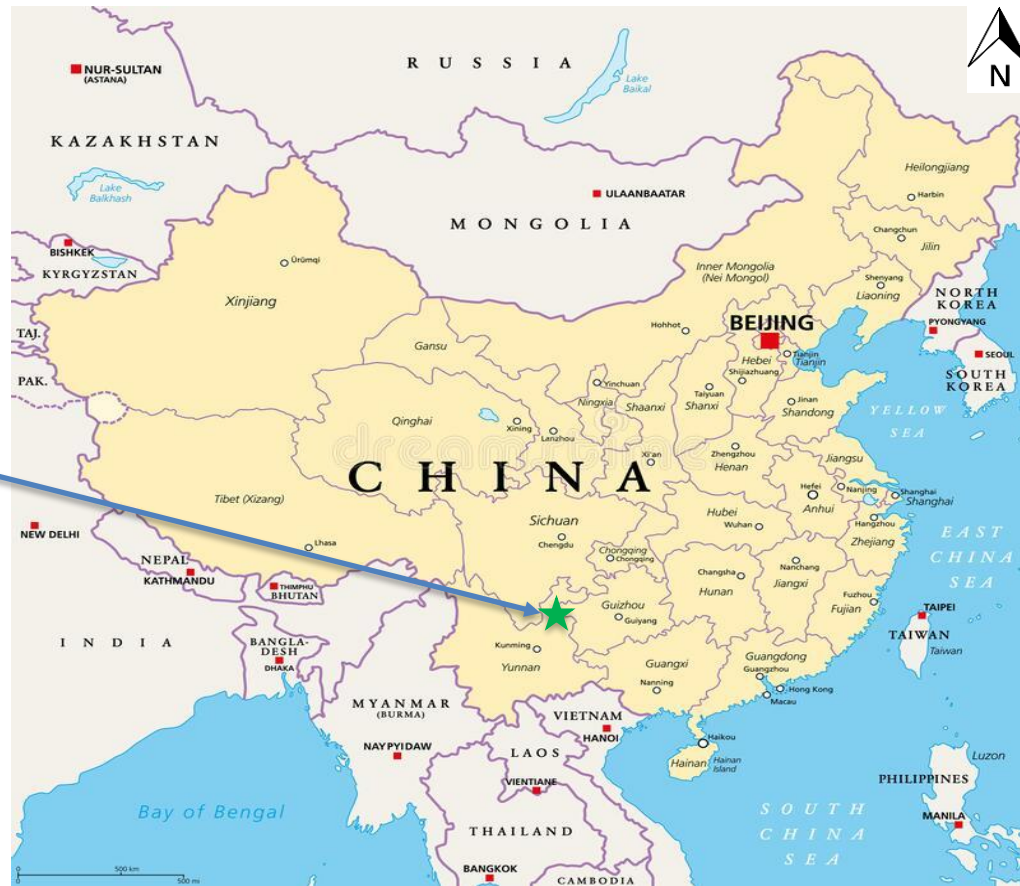
Site location: Huizhe County, North Zhehai Basin, Qujing, Yunnan Province, China .

- Remediation for a contaminated waste dumpsite using vertical barrier.
- It is a smelting plant producing zinc, lead, germanium, and other non-ferrous metals .
- The plant has been operating since 1965, the byproduct from the smelter has been accumulated year by year from the water-quenched slag and mixed with domestic waste and construction waste from the towns nearby; this has eventually caused an impact to the surrounding environment.
- In 2014 an investigation was carried out to study its impact and design a site remediation, to restore the contaminated site, stop the leachate from further migrating to the downstream.

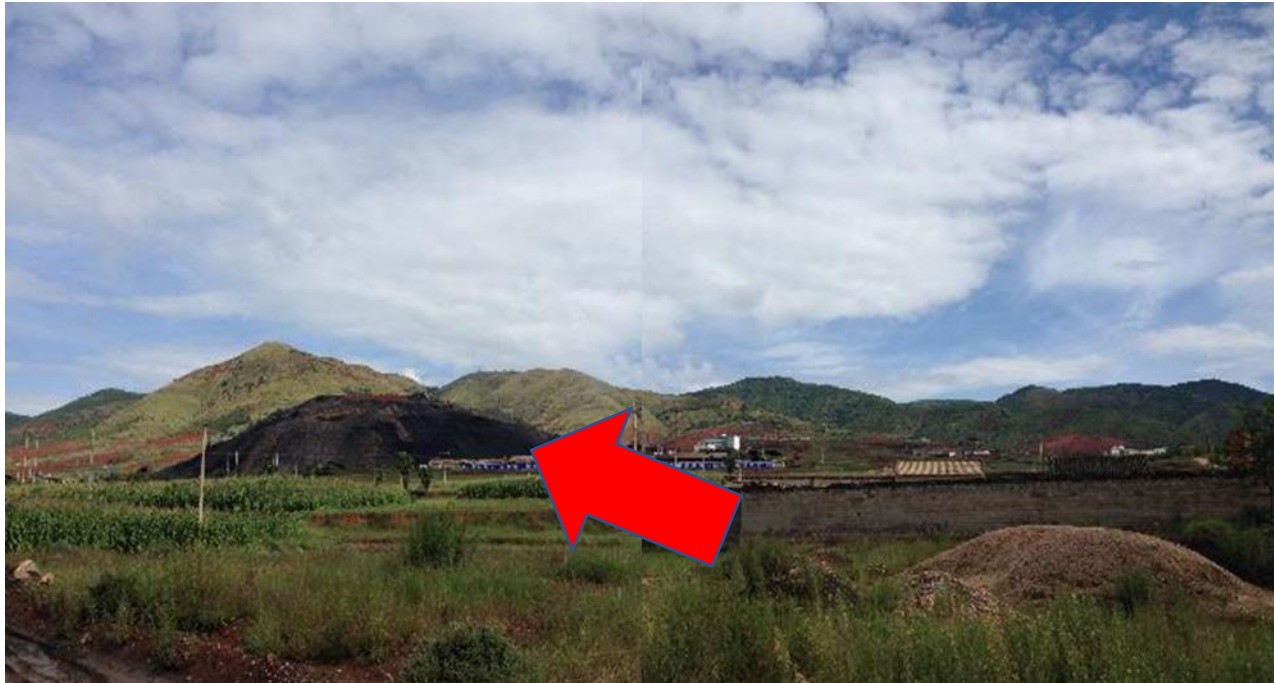
# The Waste Dump

- Location: Yunnan, Southwest of China.
- More than 50 years of smelting slag waste dump site without base liner
- Waste coverage area 110,000 m<sup>2</sup>, dump height more than 70 m, total slag volume about 3 million cubic meters.
- The wastedump contains high toxicity. Without a proper base liner system, the leachate from the wastepile has gradually contaminated the soil & groundwater at downstream, which has affected the daily life of the nearby local residents.

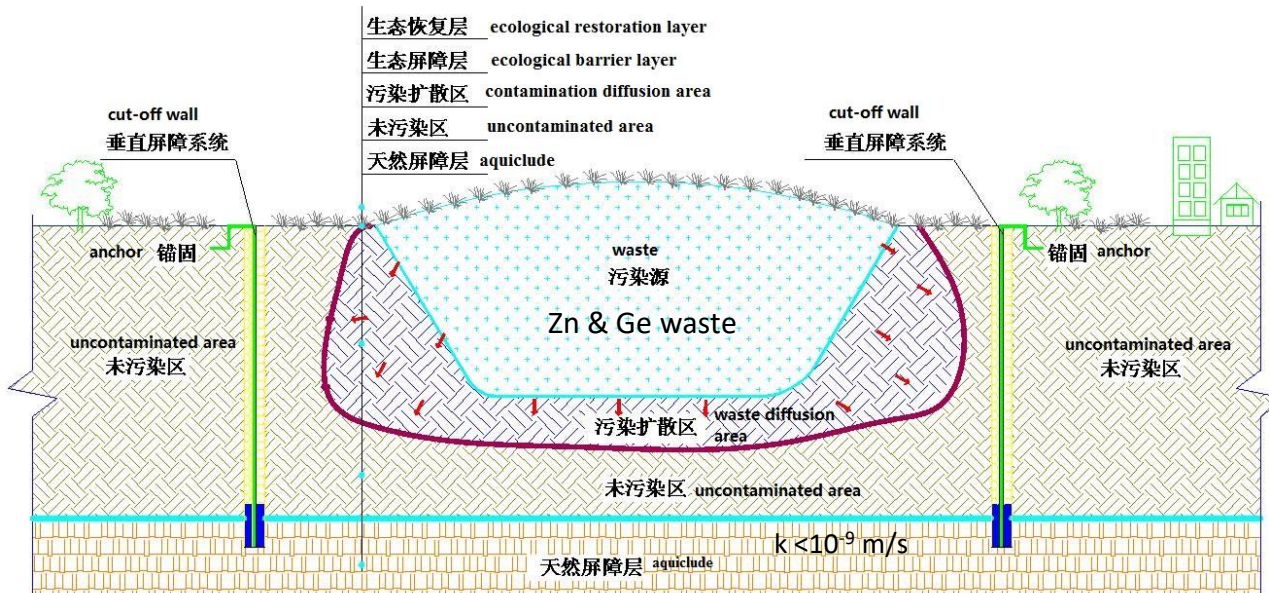
# Vertical Barrier Wall

HDPE Cut-off wall was designed and constructed in the upstream and downstream of the waste pile, penetrated to the low permeable clay layer, to stop the migration of contaminants. Width of excavated trench **0.6m**.

- Total length of HDPE barrier = 702m
- Total barrier area = 15,000m<sup>2</sup>
- Depth of barrier = 10 – 30m

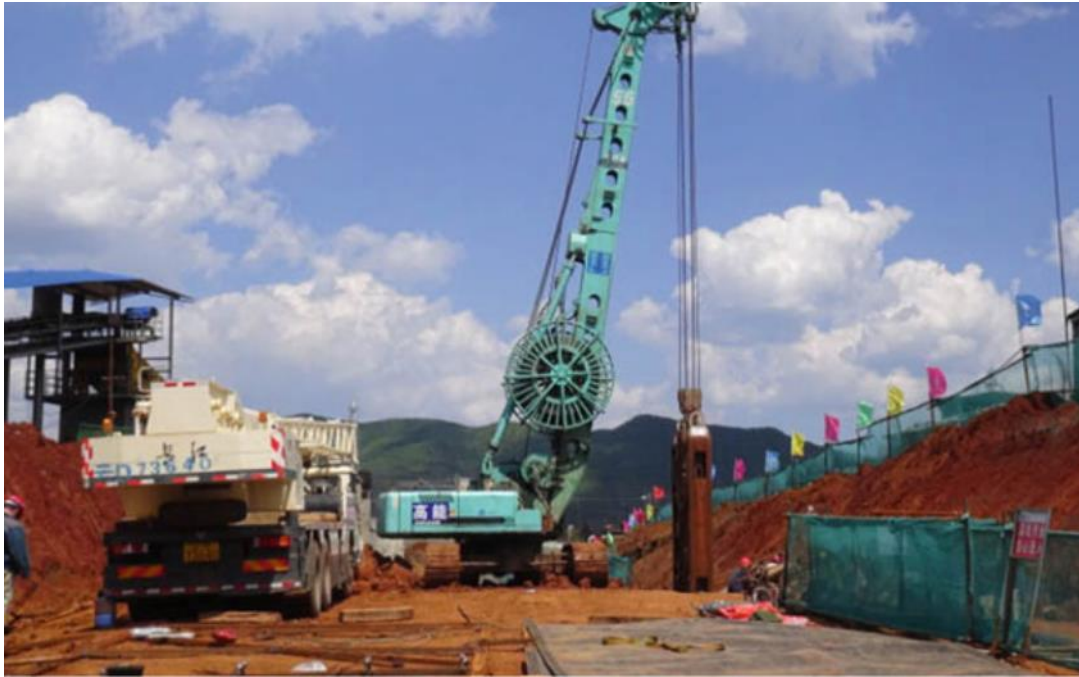
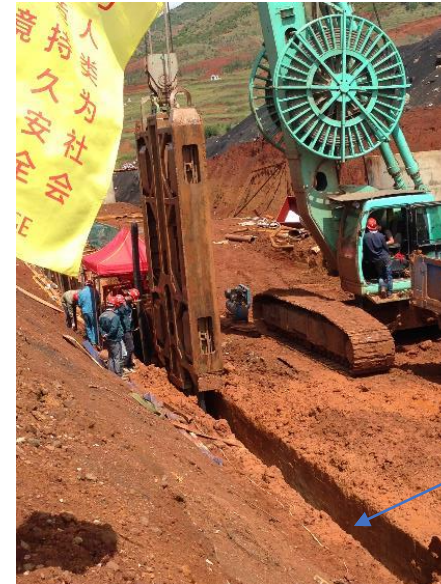
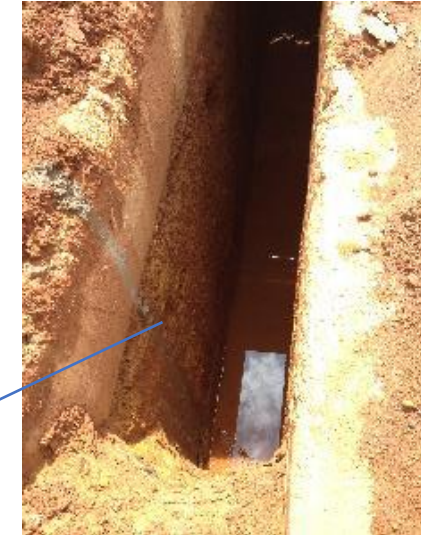
# Trench Excavation

2m deep concrete guide wall

- Depth of excavated trench: 10-30m;
- Width of the excavated trench: 0.6m;
- Thickness of sealant at the trench base : 0.5m
- Bentonite slurry used to stabilize the trench during excavation
- Excavation started from the southeast corner

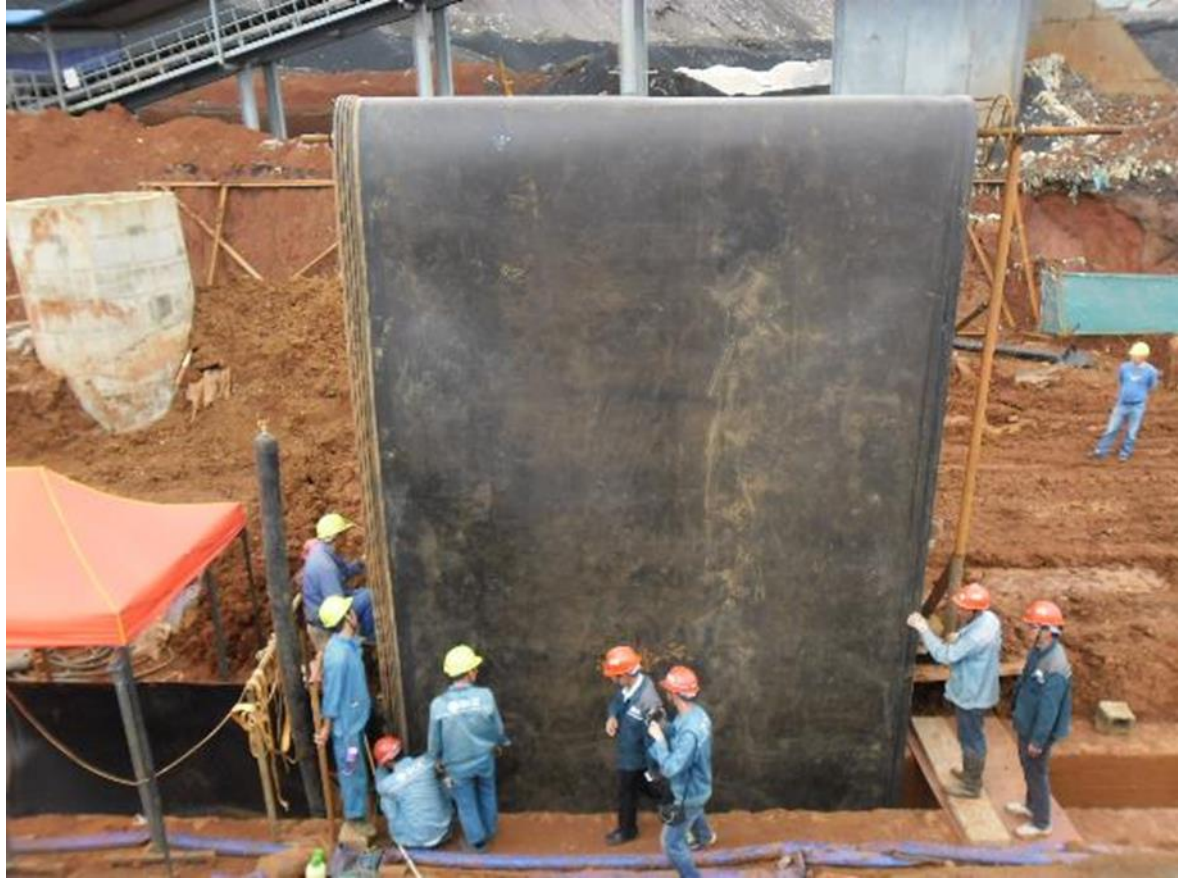
# HDPE Panel Installation

- 3mm CurtainWall panels at 4m width ~19,000m<sup>2</sup>
- $\phi$ 8mm HyperTite ~ 3,600m ;
- 6840 nos. of CurtainWall interlocks

- The site was quite windy and because of the sensitive surrounding communities, tall steel frame was not permitted by the safety officer.

- An installation drum facilitated with hydraulic jacks was used for the installation..

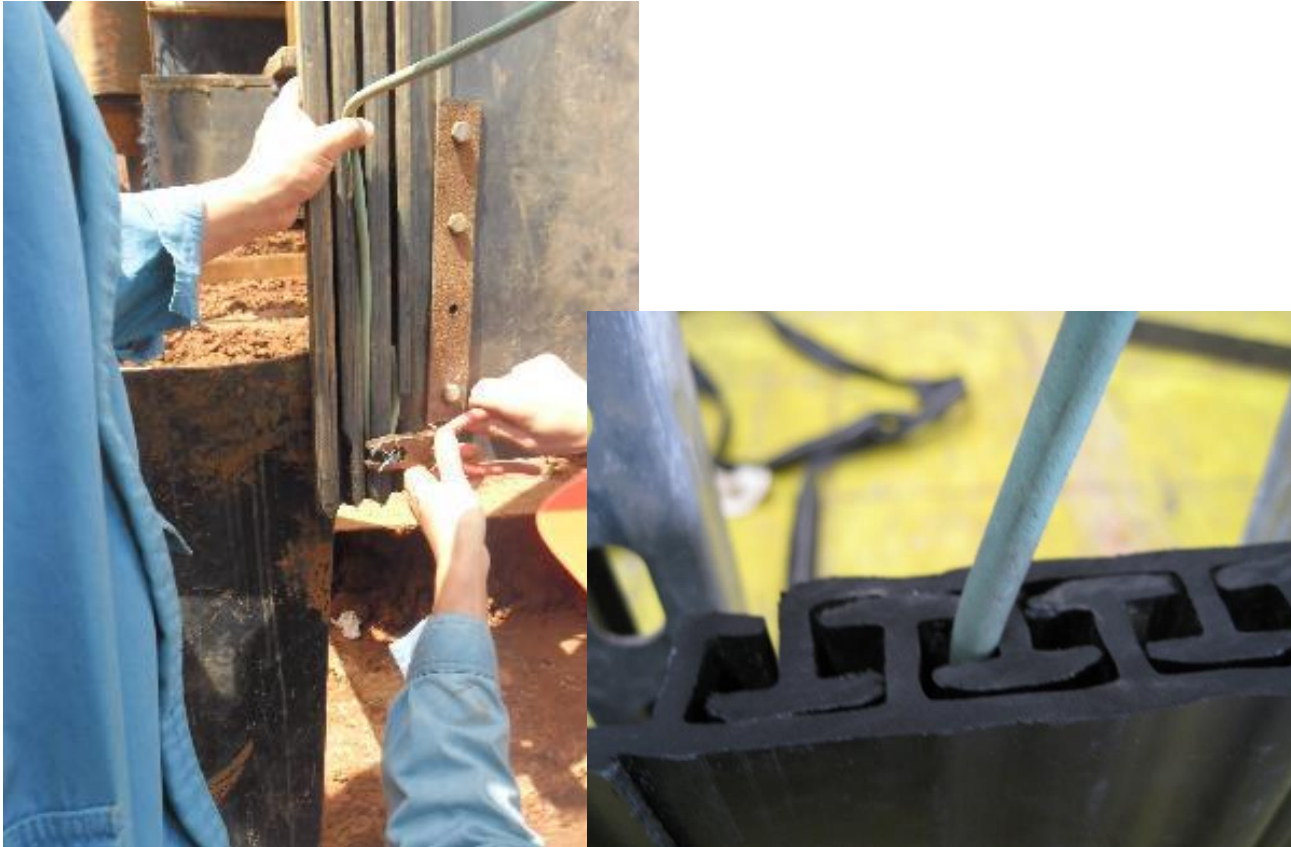
# Installation with Sealant Insertion

- The lead panel is positioned in the trench, before the installation of subsequent panel, HyperTite rubber sealant in rod form was fixed at the toe of the panels to be installed and then inserted into the chamber of the interlock.
- the rubber sealant was fed in the right chamber and the two panels were securely locked with each other.

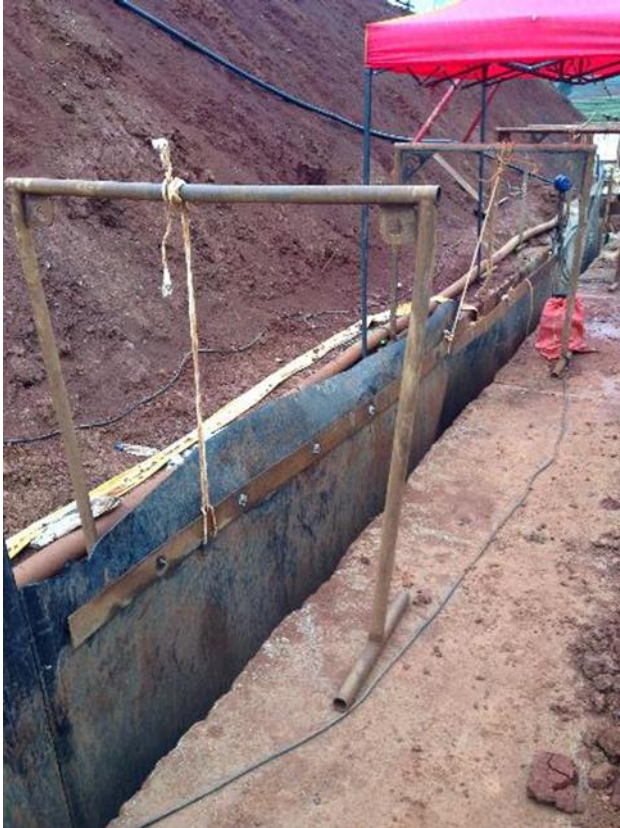
# Final Placement of the Vertical Barrier

- At the time one panel has been put in place in the trench, the panel will be attached to a steel frame standing in the trench to offer structural support, until the next connecting panel is completed then only the steel frame supporting the first panel can be removed.
- Once the HDPE panels are completely installed, the HDPE panel base was grouted & sealed, leak detection was performed with sensors connected with a cable at 0.65m spacing lowered down vertically in the trench
