A story of elevated leakage, whales and the forensics journey...

AKA... Brittle Stress Cracking of HDPE Geomembrane caused by Localized Over-Heating of Fusion Wedge Welds

GEOANZ #1

ADVANCES IN GEOSYNTHETICS
7-9 JUNE 2022 | BRISBANE CONVENTION & EXHIBITION CENTRE

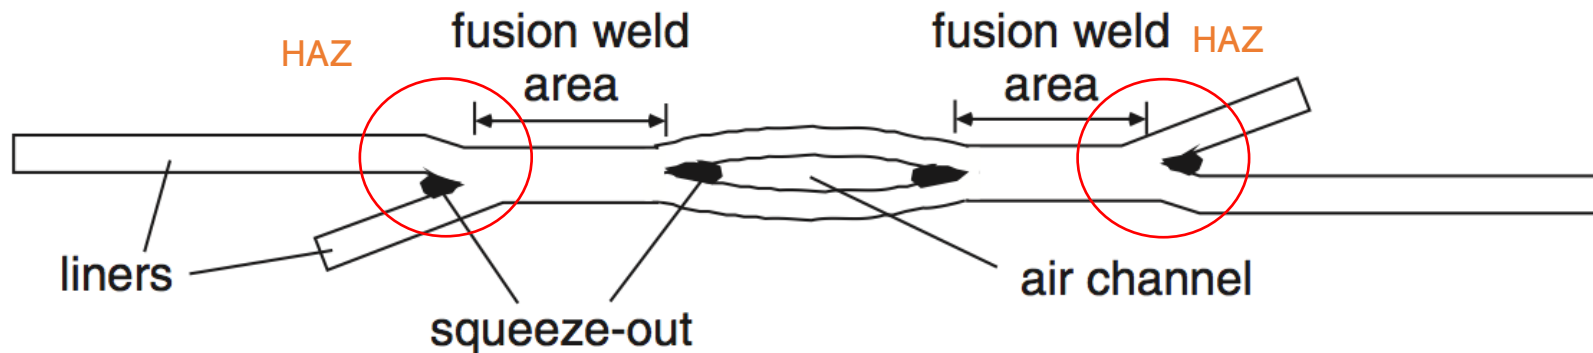
- Select the appropriate tests to help your hypothesis, there are many to choose from
- The splits were located in the Heat Affected Zone (HAZ)
- Based on the HAZ observations we selected the following tests:
 - Assessing weld profile changes – **thick-thin transitions in the weld profile impose stress concentrating geometries**
 - Std OIT – **consumption of antioxidants during welding reduces stress cracking resistance**
 - Flexural cycle – **subjects the weld track (including the HAZ) to low amplitude cyclic stress in the form of flex cycles**
